## LONG-TERM EFFECTS OF EARTHQUAKE-INDUCED SLOPE FAILURES

**Ikuo Towhata**

The University of Tokyo  
Tokyo, Japan 113-8656

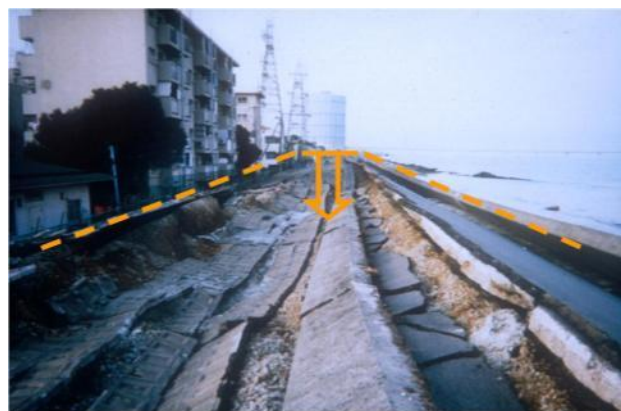
*Fig. 1. Liquefaction-induced distortion of Yodo river levee in 1995*

The first example is taken from a river levee. Traditionally, seismic resistant design was not compulsory in river levees because the probability of simultaneous occurrence of strong earthquake and flooding was considered to be low enough. Hence, in case of any seismic damage, quick restoration before the occurrence of flooding has been the engineering objective. This principle failed during the 1995 Kobe earthquake when Yodo-River levee was destroyed by liquefaction (Fig. 1).

Because of the occurrence of more than 3-m subsidence at the levee crest, it was found that the high tide near the river mouth is virtually a flooding that occurs twice a day. This is particu-

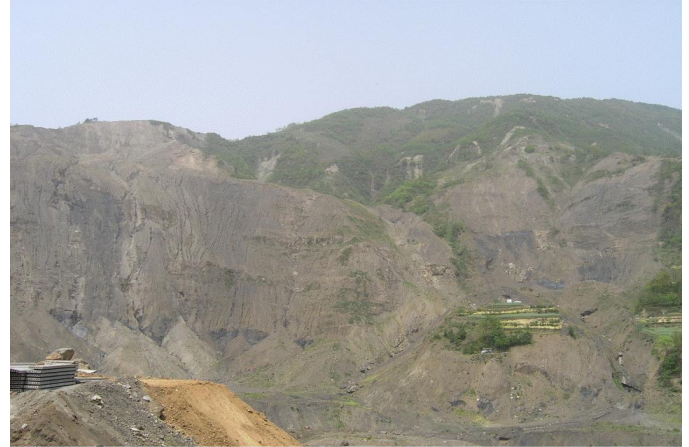
*Fig.3. Earthquake-induced failure of mountain slope with Li Jia Village on (2008 Wenchuan earthquake in China)*

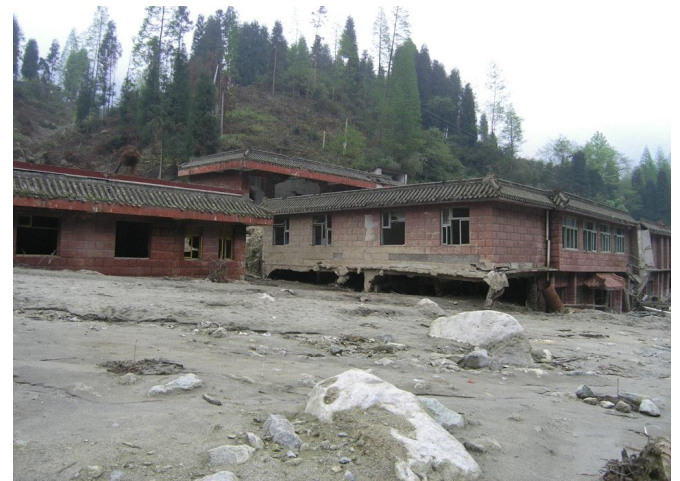
*Fig.4. Consequence of debris flow in Yinchanggou in September, 2008, after the Wenchuan earthquake in May of the same year*

Figures 4 and 5 illustrate the consequence in Yinchanggou, Sichuan Province of China, where rainfall-induced debris flow started to attack this once-famous summer resort. This bad situation was caused by the seismically-destabilized slopes in the mountains behind this town (Fig. 6).

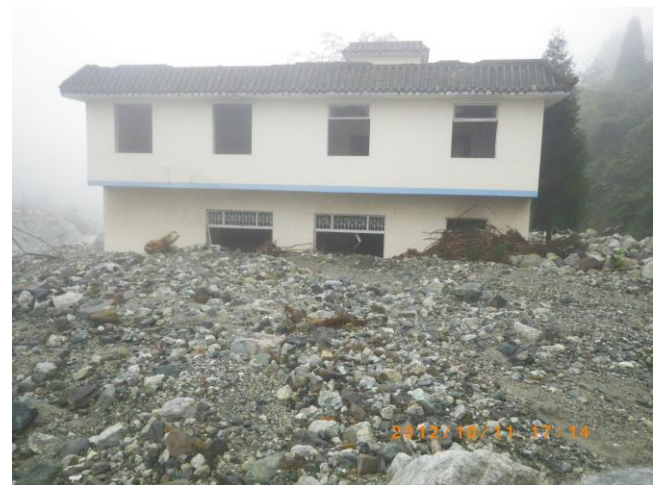
*Fig.5. Yinchanggou in October, 2012, after repeated debris flow during rainy seasons*

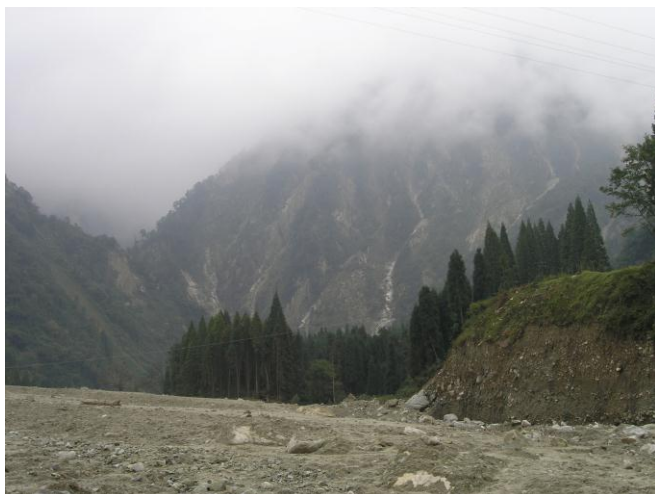
*Fig.6. Unstable mountain slopes during rain behind Yin-changgou (October, 2012)*

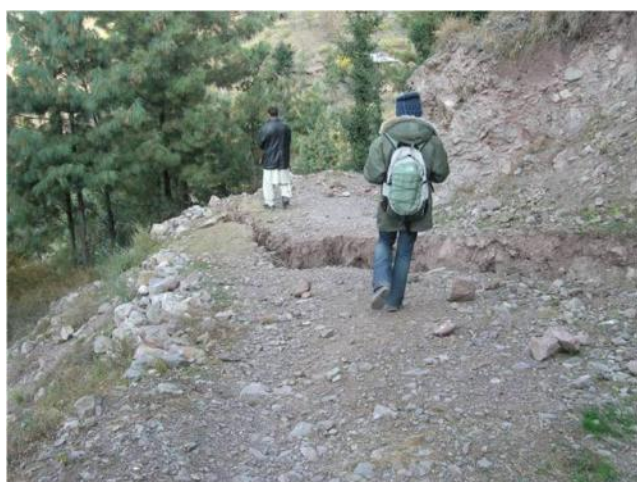
*Fig. 7. Earthquake-induced crack in mountain slope (North Pakistan, October, 2005)*

A more detailed situation of a seismically-destabilized slope is illustrated in Fig. 7. After a gigantic earthquake in North Pakistan, 2005, a reconnaissance was made by the author. This figure indicates a big crack in a mountain slope after the earthquake and rain water can easily percolate into the slope through it, affecting the long-term slope stability.

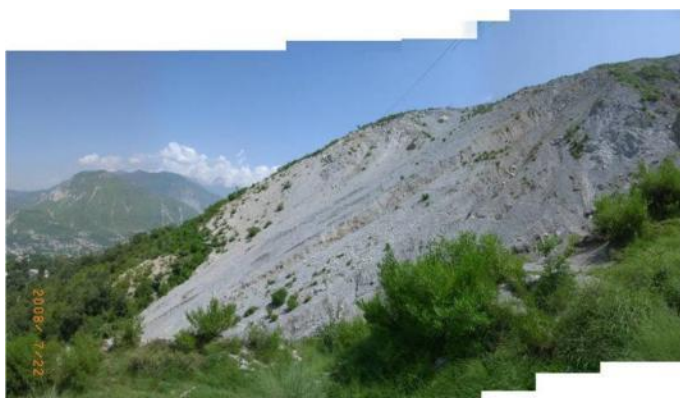
*Fig. 8. Seismically affected slope behind Muzaffarabad of Pakistan*

Another mechanism of the compound effect is found in the continuous failure of mountain slopes behind Muzaffarabad, Pakistan after the 2005 earthquake. Although this slope was stable before the earthquake, debris flow started to occur frequently thereafter (Fig. 8). As shown in Fig. 9, there is no such a big crack in this figure as in Fig. 7 and it is supposed that the stronger shaking deteriorated the stone by developing many micro cracks and fissures.

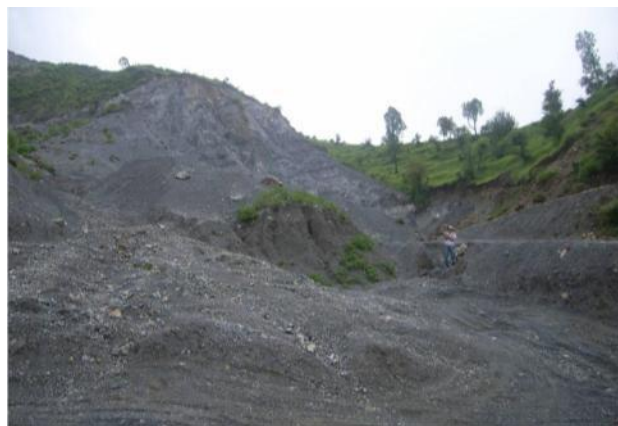
*Fig. 9. Details of unstable slope behind Muzaffarabad(summer, 2008)*

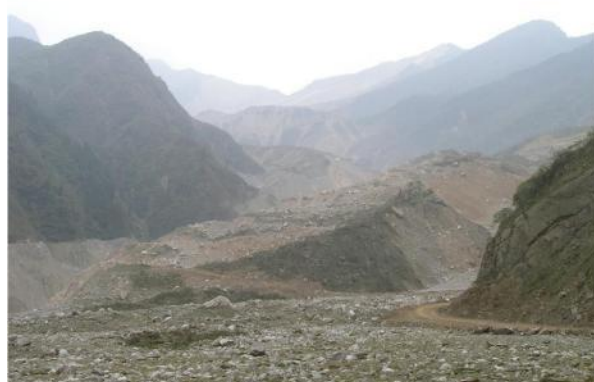
*Fig. 10. Unstable debris deposits in valley bottom at Wenjiagou of Qingping of Sichuan Province)*

A totally different mechanism of a long-term compound effect is shown in Fig. 10. The 2008 Wenchuan earthquake triggered many gigantic slope failures as stated above and this figure illustrates a typical situation in valleys afterwards. In August of 2010, heavy rainfall in this area caused a huge size of debris flow to start from this unstable deposit. Because a similar debris flow had caused a disastrous damage in Zhouqu County to

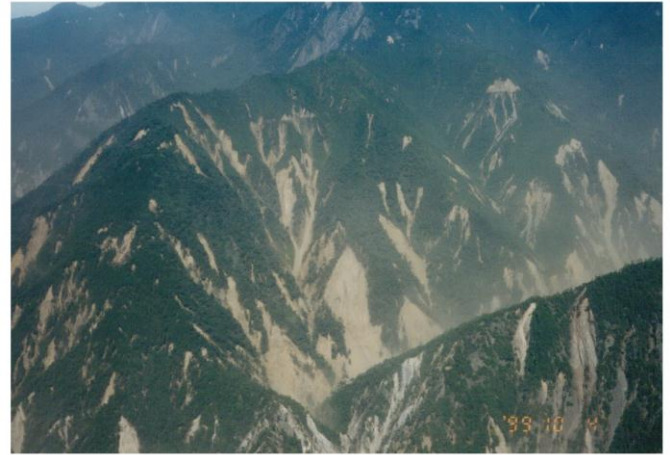
*Fig. 11. Damaged mountain slope in Taiwan immediately after the 1999 Chi-Chi earthquake*

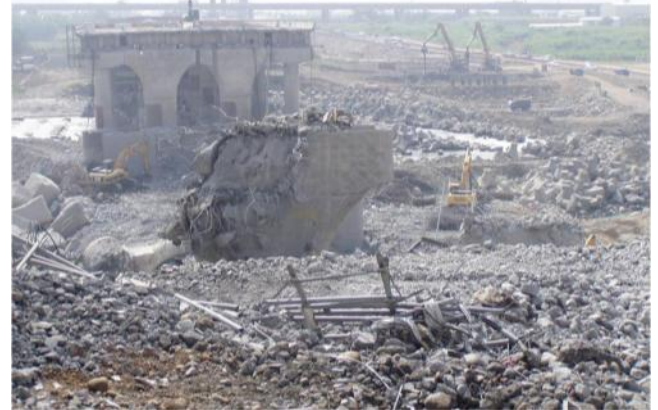
*Fig. 12. Debris flow in Taiwan in 2008.*

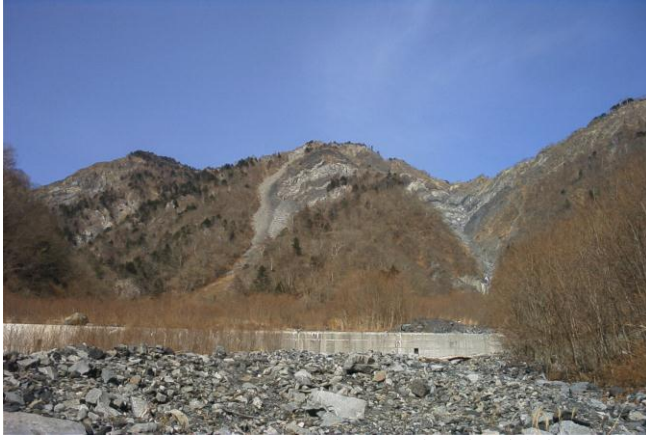
Fig. 14. Continued instability of Ohya landslide site

A more evident and profound effect of precedent earthquake can be found at the site of Ohya landslide, which is located at about 100 km to the west of Tokyo; see Fig. 14. It is said that this landslide originates from a big failure induced by a gigantic earthquake of  $M_w = 8.7$  in 1707 or even an earlier one (Takeuchi and Tsutsumi, 1985) that occurred in the subduction zone in the Pacific Ocean. Since then, for hundreds of years, this site has been producing debris flows during heavy rains. Thus, it is possible that the compound effect lasts for a long time if the environmental and geological situations are adverse.

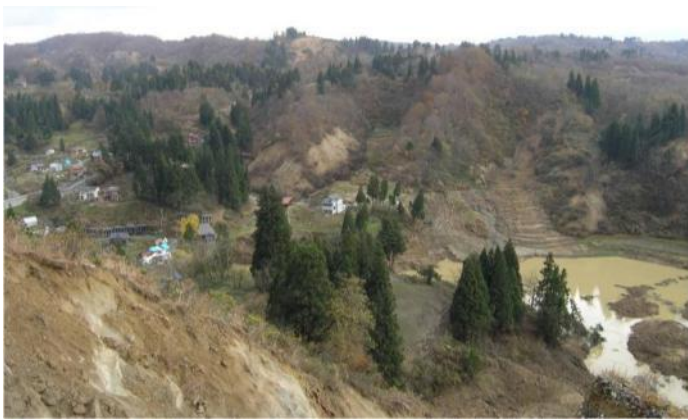
Fig. 17. Safe location of residences in earthquake-affected Yamakoshi Village of Niigata-Chuetsu in 2004

This chapter briefly addresses two findings of possible wisdom of people. Fig. 17 was taken in Yamakoshi Village where the 2004 Niigata-Chuetsu earthquake caused many slope failures. It is interesting that people's houses in this photograph are situated on stable parts of slopes while surrounding slopes deformed or failed. This situation was in good contrast with damage of livestock houses and public buildings in the same village that were located on unstable slopes. It was impressed during this field study that the village history of 1000 years gave people non-engineering knowledge where to live. Possibly, modern geotechnical engineering is not fully developed to know everything.

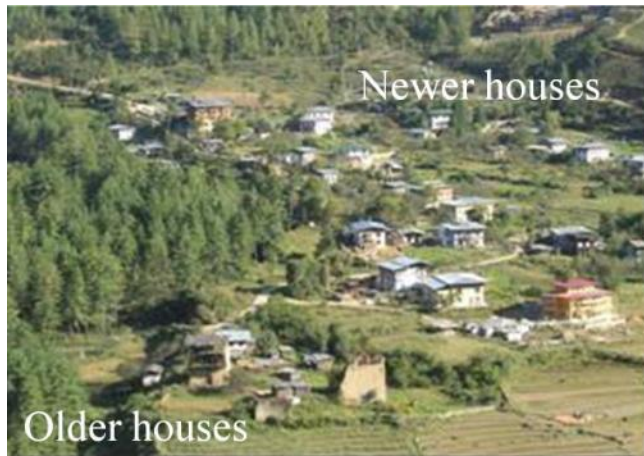
Fig. 18. Safe location of residences in fluvial fan where flooding and debris flow are possible to occur (Thimphu, Bhutan)

Another wisdom was found upon a fluvial fan near Thimphu, the capital of Bhutan. Fig. 18 shows that older houses are located behind a forest probably for protection from flooding and debris flow, whereas newer houses are located near the center of the fan which is more vulnerable to natural disasters.

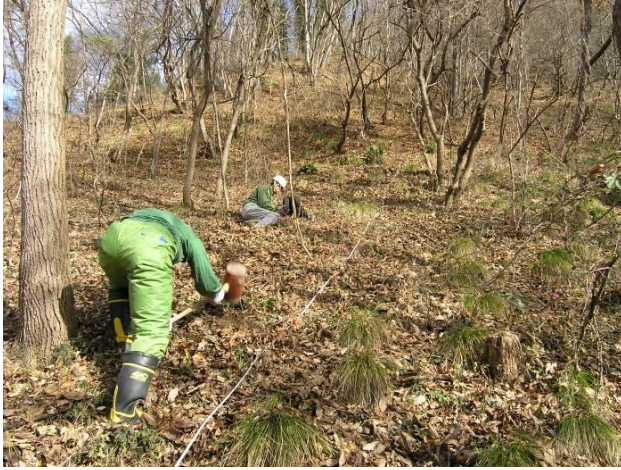
Fig. 19. Seismic refraction survey upon weathered mountain slope (near Ikezawa Pass, Nagano)

Figure 19 illustrates an ongoing S-wave velocity ( $V_s$ ) measurement (seismic refraction survey) for which geo-phones are deployed along the ground surface and shaking is produced by vertical impact of a hammer on the slope surface. Whether the involved ground motion is that of S wave or Rayleigh wave, their propagation velocities are of minor difference (less than 10% or possibly 5%), which is geotechnically negligible. By using the traditional method of data interpretation,  $V_s$  and the

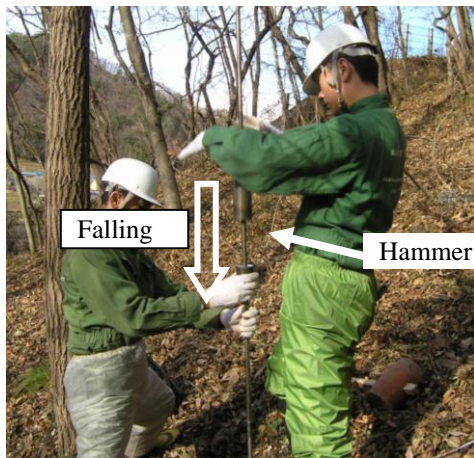
Fig. 20. Portable dynamic cone penetration test (near Ikezawa Pass, Nagano)

thickness of the surface weak layer are determined. The aim of the Vs survey is a development of relationship between Vs, which is easily measured in the field, and shear strength parameter of the slope, which is essential in a slope instability judgment. To obtain the strength for this research, portable cone penetration tests were run as well. For this test, a hammer of 5 kg mass falls 50 cm and the number of blows ( $N_d$ ) for 10 cm penetration of the cone tip (60 degrees and 2.5 cm in diameter) is counted (Fig. 20).

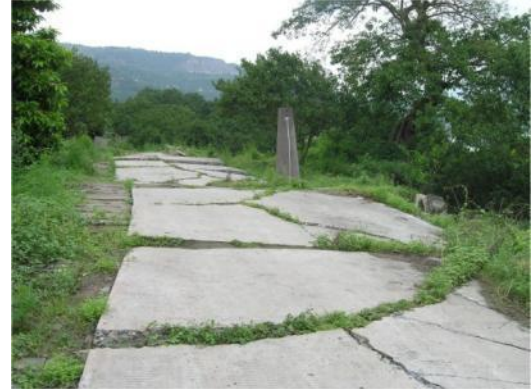
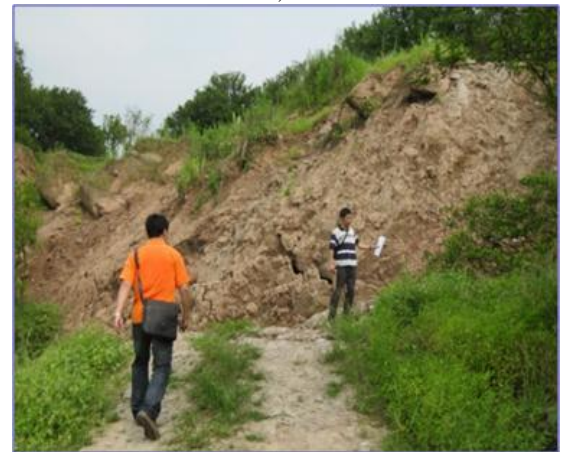
(a) Prior to failure (May 2009)

(b) After failure on 7th of June, 2009

Fig. 24. Monitored slope along the Three Gorge Dam Reservoir, China

Figure 24 illustrates one of the monitored unstable slopes along the Three Gorge Reservoir of China. The filling of the reservoir after completion of the dam induced loss of effective stress in the lower part of slopes and, consequently, many

slope failures occurred. At this particular site, a failure occurred on June 7th, 2009.
